# **PRESERVATION ASSESSMENT OF THE ELM STREET CEMETERY, BRAINTREE, MASSACHUSETTS**

**Chicora Research Contribution 529**

Prepared By:  
Michael Trinkley, Ph.D.  
Debi Hacker  
and  
Nicole Southerland

September 2010

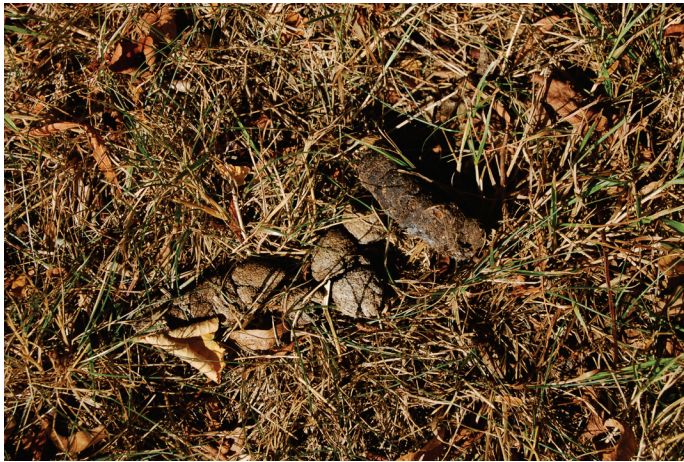
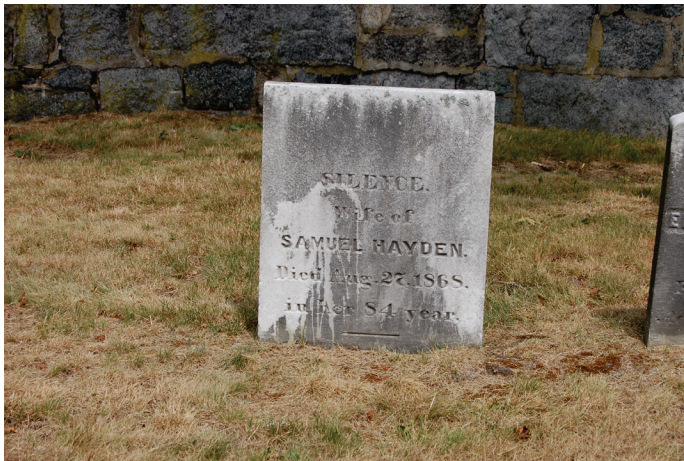
Figure 13. Damage caused by dogs in the cemetery. Top photograph shows dog feces in the cemetery. Bottom photograph shows damage done to a stone by dog urine.

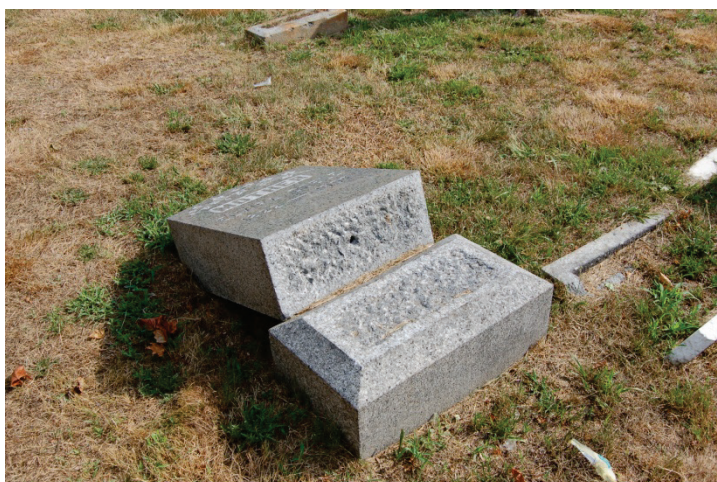
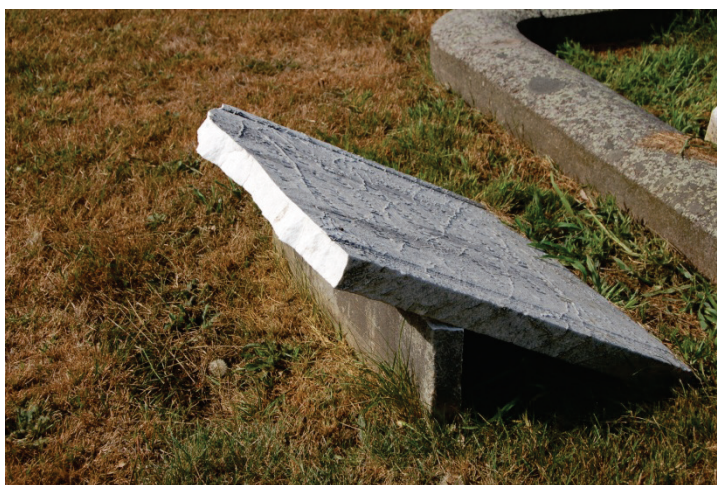
Figure 14. Examples of recently vandalized stones. The top photograph shows a heavy stone on a level base that would not have toppled without assistance. The lower photograph shows a freshly broken marble edge.

condition – they would be immediately repaired or replaced. Likewise, it is critical that vandalized stones be repaired by a stone conservator.

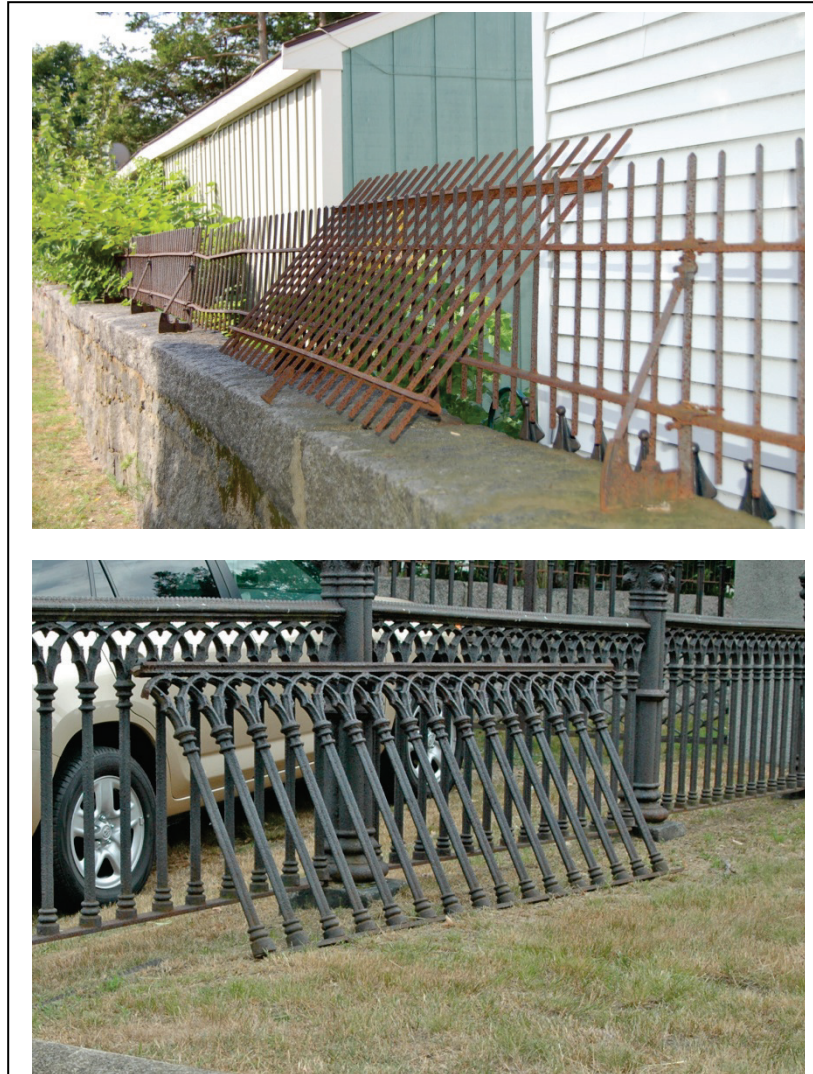
Figure 15. Examples of ironwork that should be secured and protected. Leaving these items scattered in the cemetery is disrespectful and invites theft of irreplaceable historic fabric.

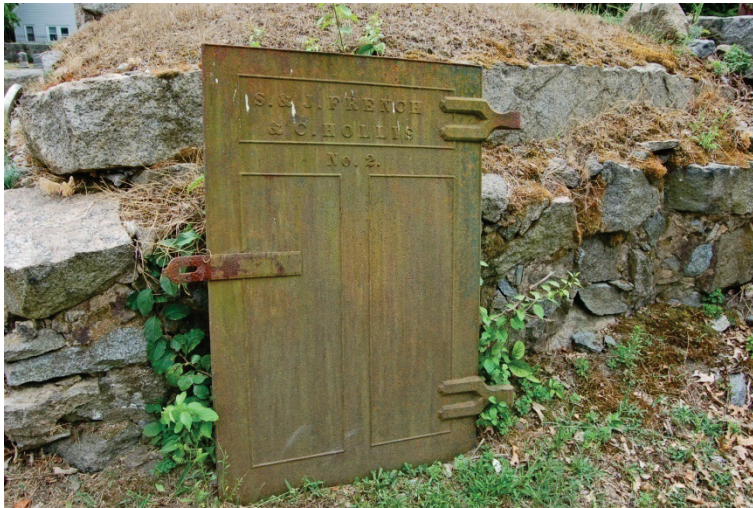
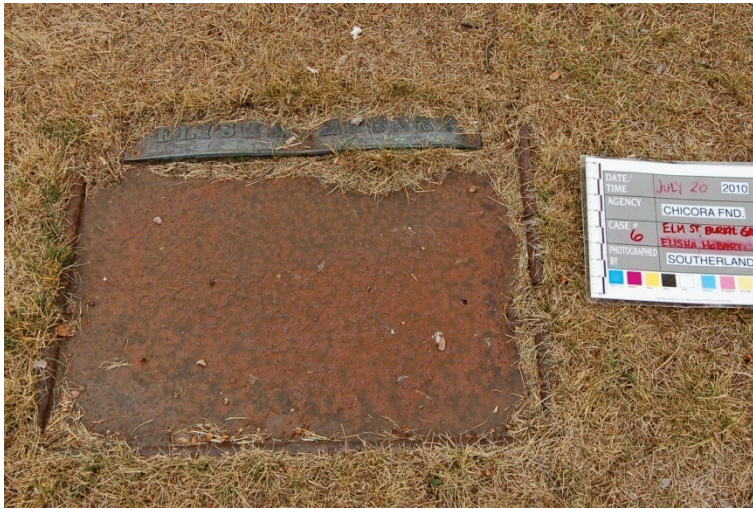
Figure 16. Remnants of two tombs demolished by the town ca. 1991.

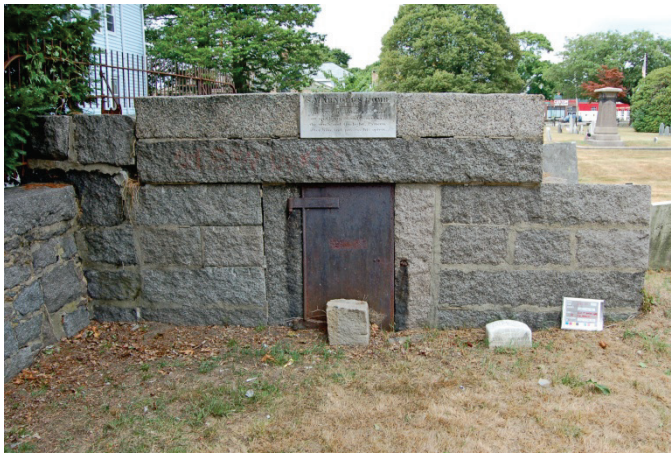
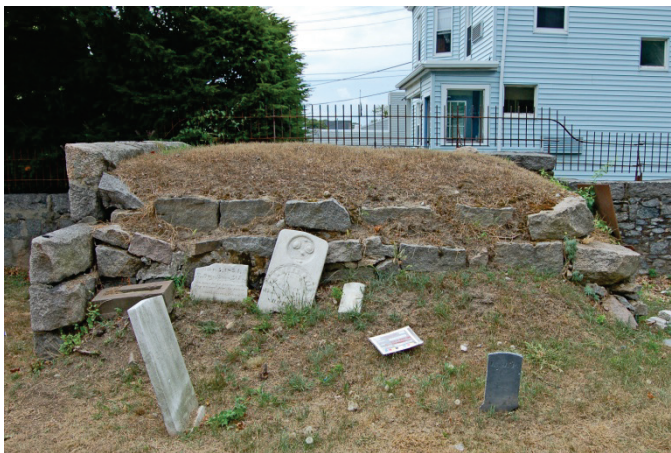
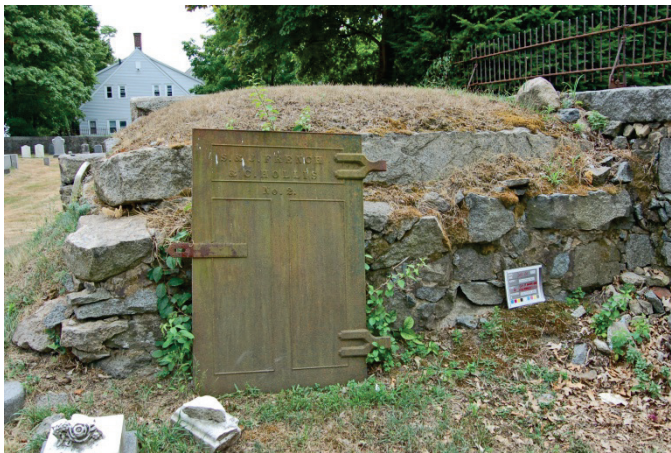
Figure 18. S.V. Arnold tomb. Top photograph shows the south façade. Middle photograph shows the east façade. Bottom illustrates the north façade.

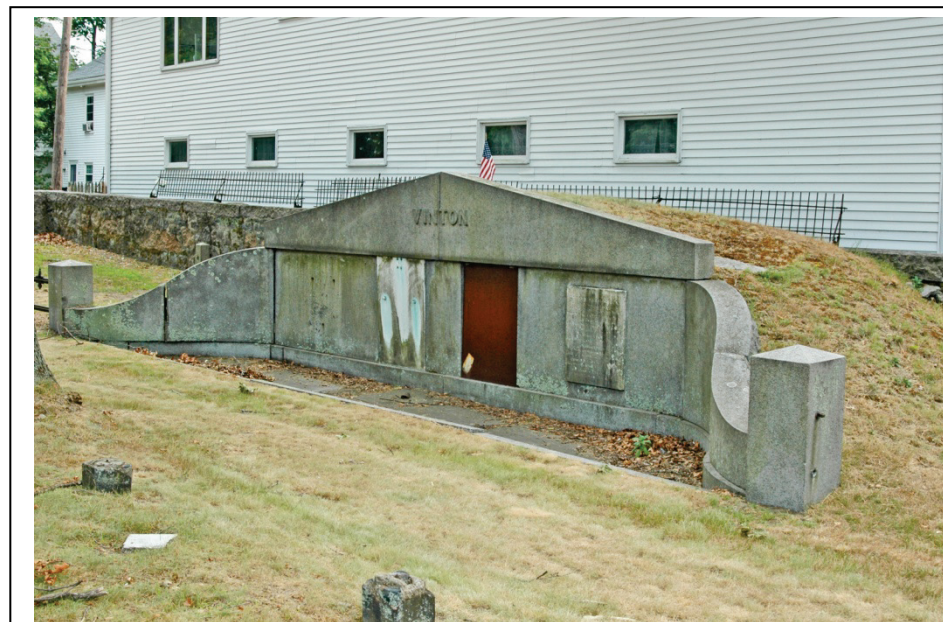
Figure 19. Vinton tomb at the south edge of the cemetery.

by 2'8" that is held in place with two wood wedges. The marble door handles are broken and the door, set on a lead threshold or cushion, is loose, but stable. The remaining marble plaque measures 2'3¾" by 2'11" by 1¼" and contains the names of six individuals (Betsy Snow Giles Vinton, Phebe W. Clisby Vinton, Josiah Vinton, Charlotte W. Vinton, Edward Payson Vinton, and William Vinton Alden).

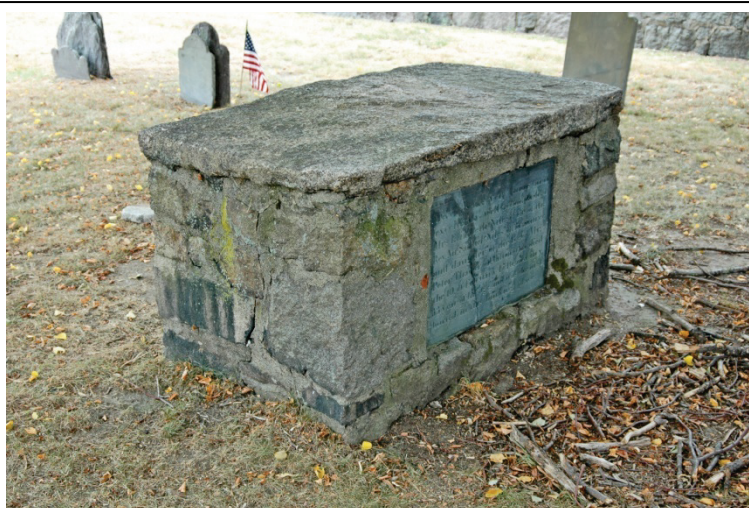
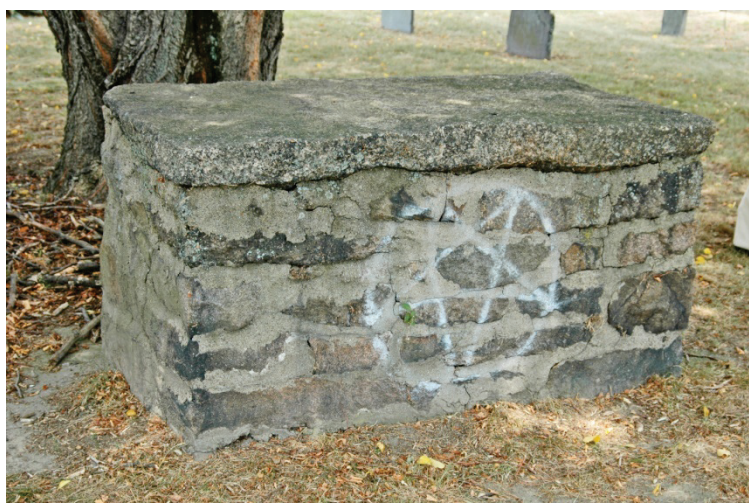
Figure 20. Elizabeth Niles box tomb. Top photograph shows the north and east facades. Bottom photograph shows the south and west facades.

As with all of the tombs, the interior should be inspected to ensure there is not hidden damage and the mound is stable.

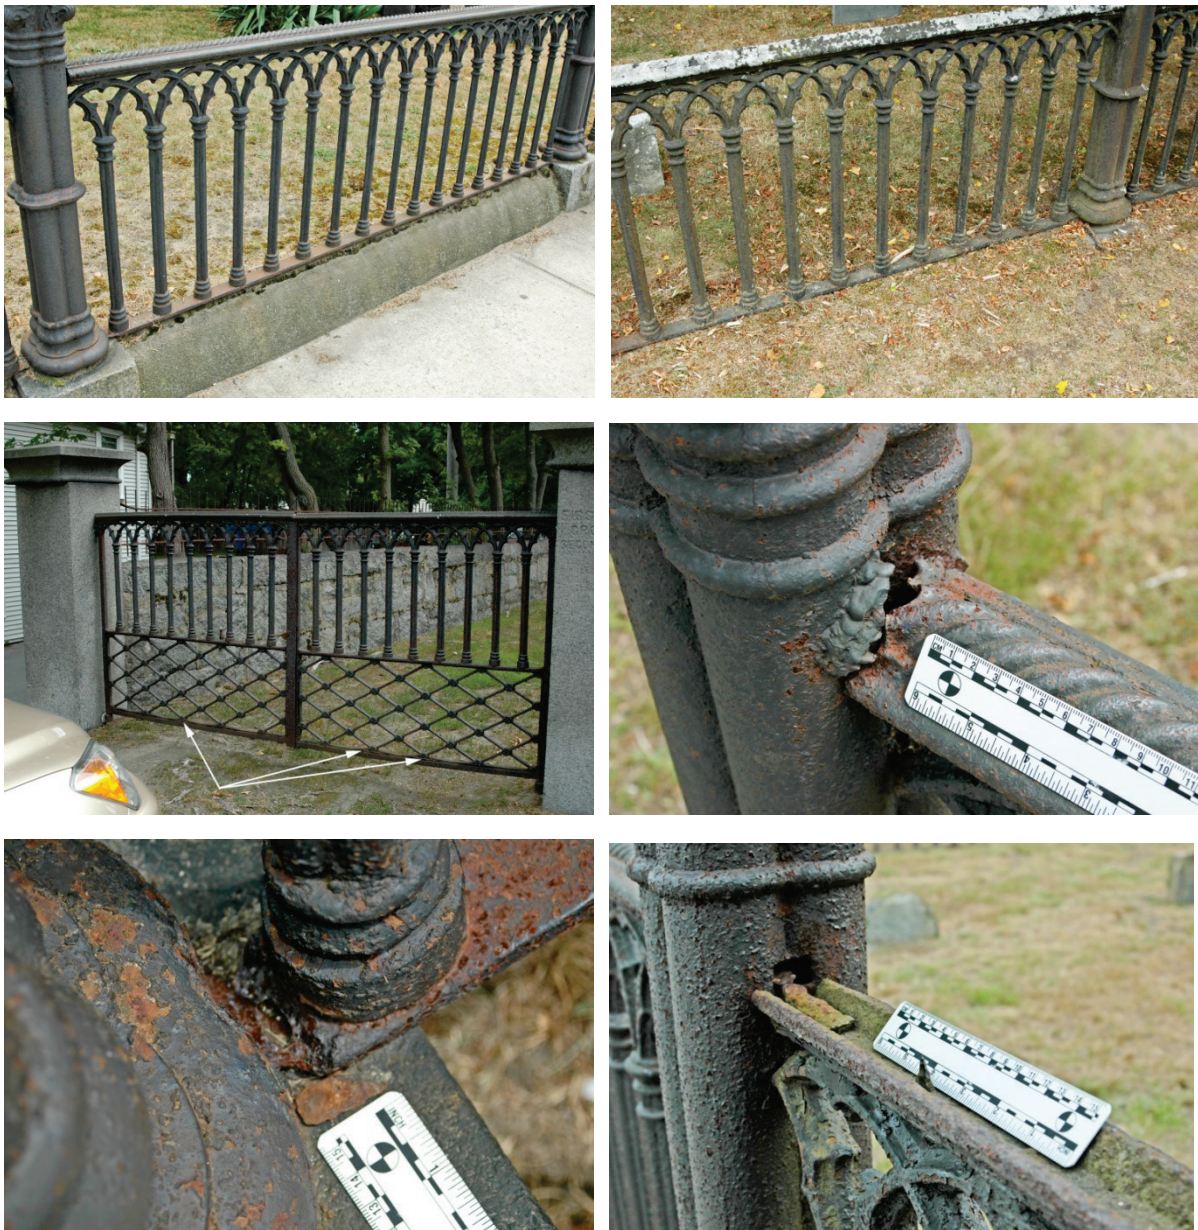
Figure 21. Elm Street fence. Upper left photo shows a fence section along Elm Street in the soil. Upper right photo shows a fence section at the west gate in the soil. Center left photo shows the east gate; note areas requiring caulking, as well as the displaced gate post caps. Center right photo shows a broken weld, as well as corrosion and pitting of the fence. Bottom left photo shows extensive corrosion at bottom rail connector. Bottom right photo missing top rail cover, as well as damaged connector.

Historic parts are found lying on the ground or leaning against the fence just inside the cemetery. All such parts should be collected and stored for repair, replacement, or replication. They should not be ignored and allowed to be stolen, destroyed, or treated as "surplus."

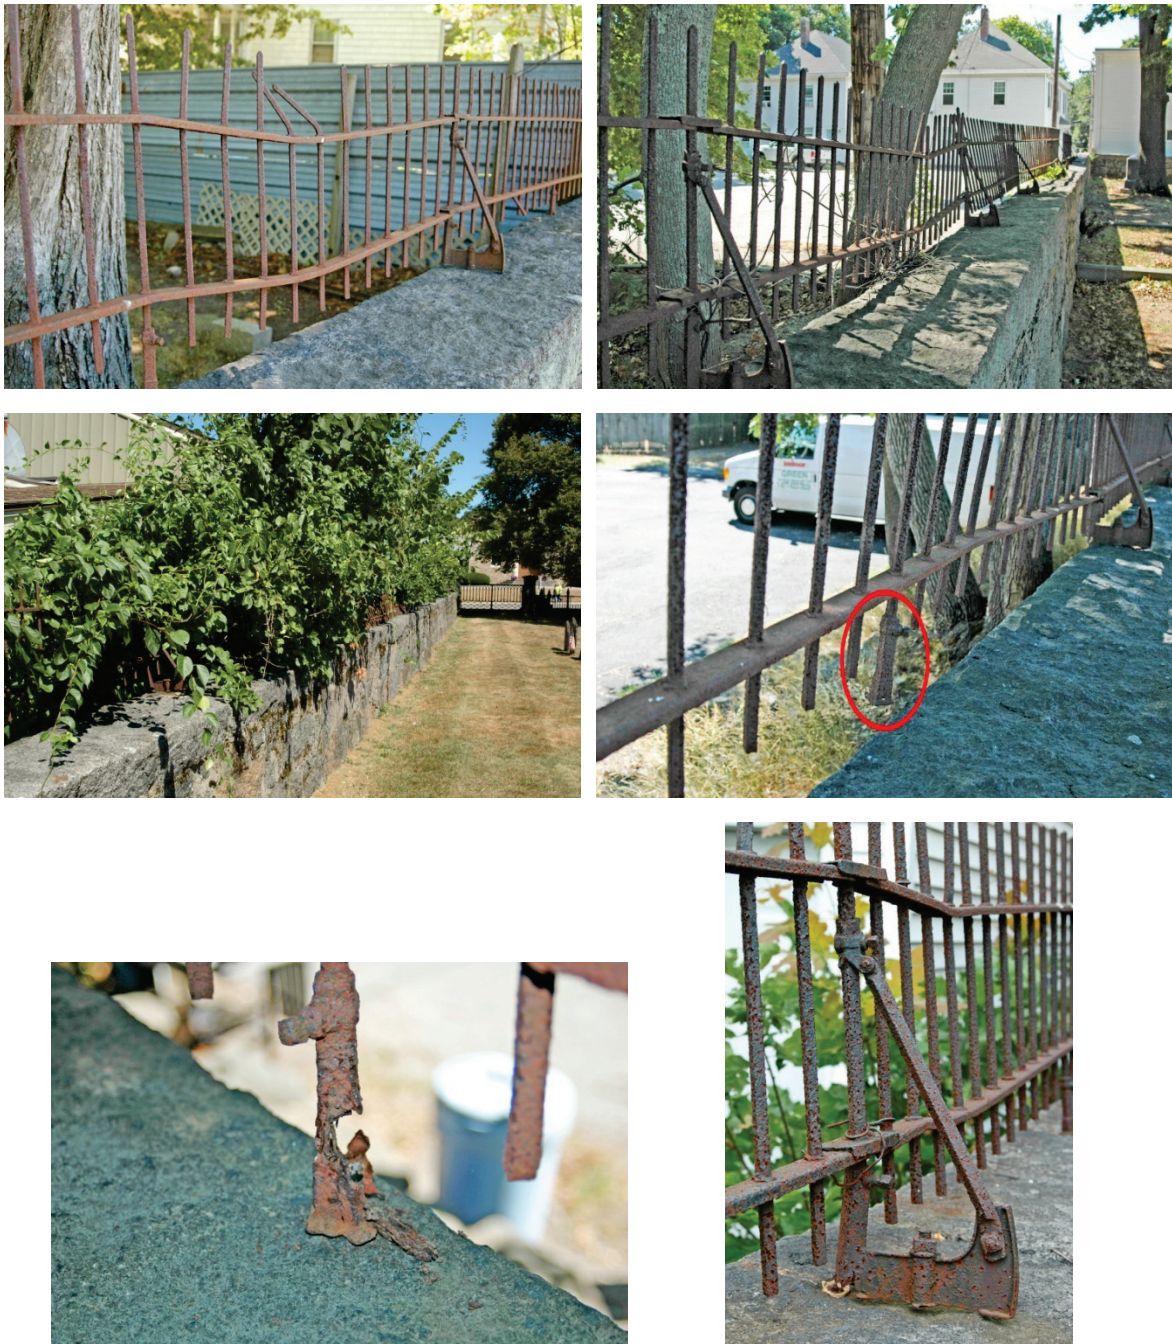
Figure 22. Perimeter fence. Upper left photo shows bent section from old tree or limb damage. Upper right shows ongoing damage from trees off the cemetery, leaning into the fence. Center left photo shows vegetation from adjacent parcels obscuring the fence. This trash vegetation should be removed. Center right photo shows a central panel support that is no longer attached to the stone wall. Lower left photo shows a central panel support that has completely failed because of extensive corrosion. Lower right photo shows a failed panel support. Note also the extensive corrosion on the fence and support.

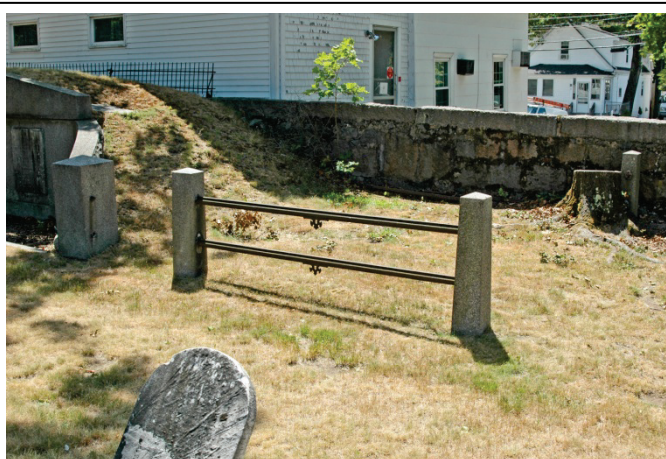
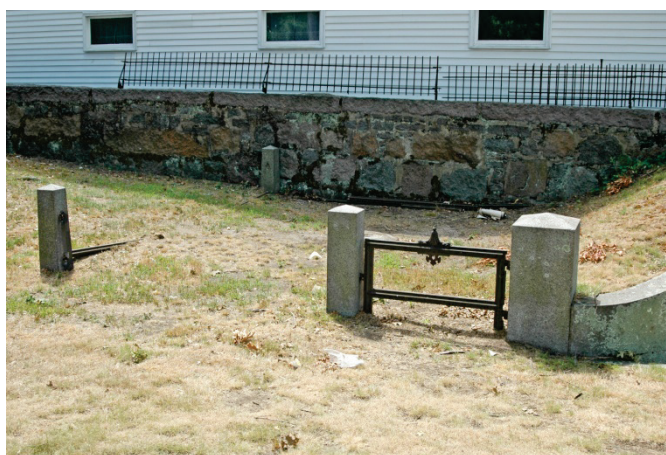
Figure 23. Vinton fence. Upper photo shows the fence on the west side of the tomb. Lower photo shows the fence on the east side of the tomb, with the gate buried in the soil and the lower side bar bent and covered in soil.

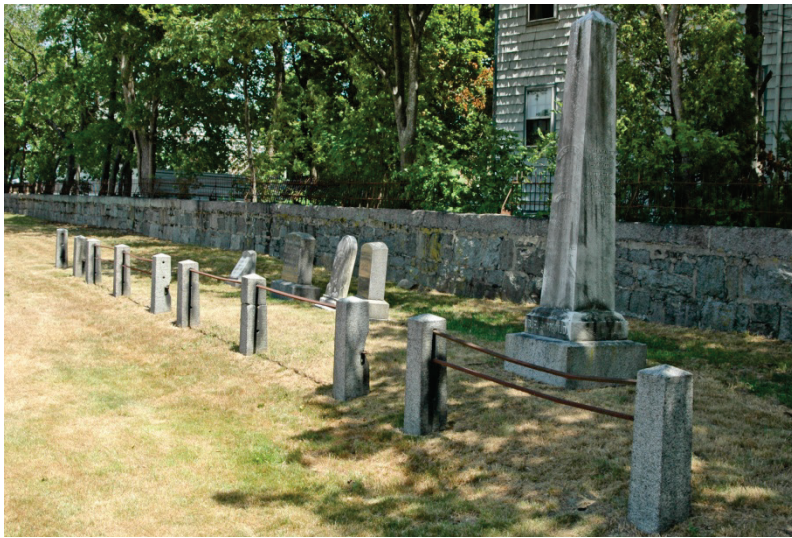
Figure 24. Arnold Family Plot fence.

The bars are  $\frac{5}{8}$ " with the opening  $6'1\frac{3}{4}$ ". The gate openings are  $2'10\frac{1}{2}$ " in width. The granite posts are 2'6" in height, with rails at 3", 10", and 19" from the top. Of the 18 rails originally set, today only seven remain. Only one of the granite columns is broken.

There is one bar on the bottom of the east side panel. This bar will require careful straightening and it should be placed in the top position.

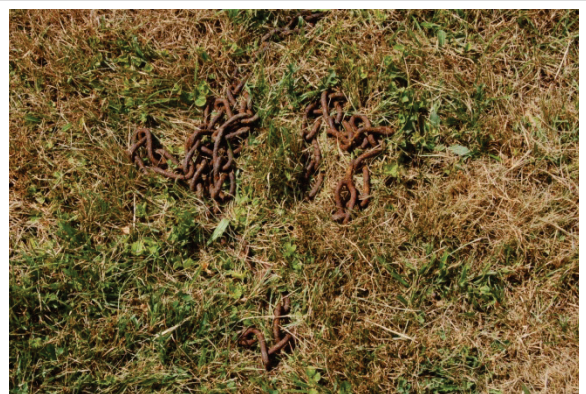
Figure 25. Portion of the chain from the French plot found scattered in the cemetery.

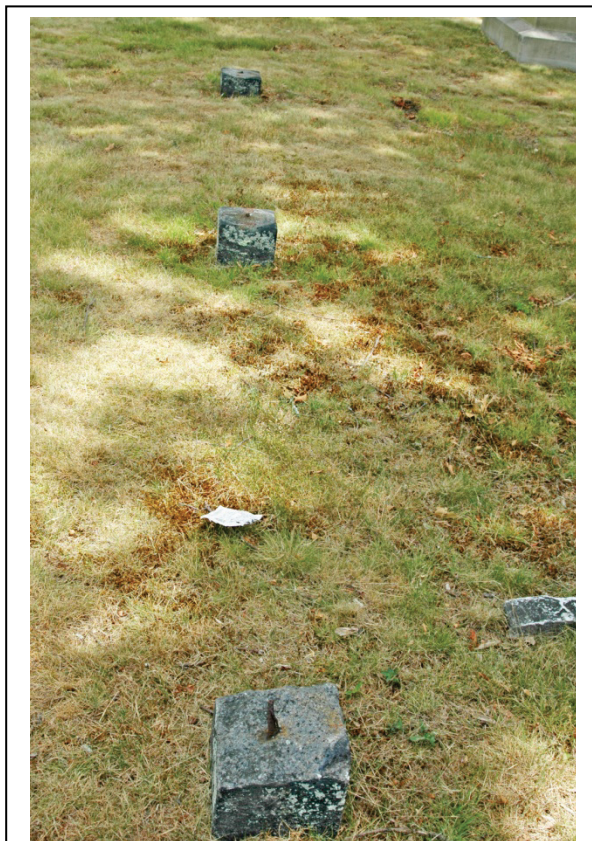
Figure 26. Lost fence documented by granite blocks and remnant iron rods.

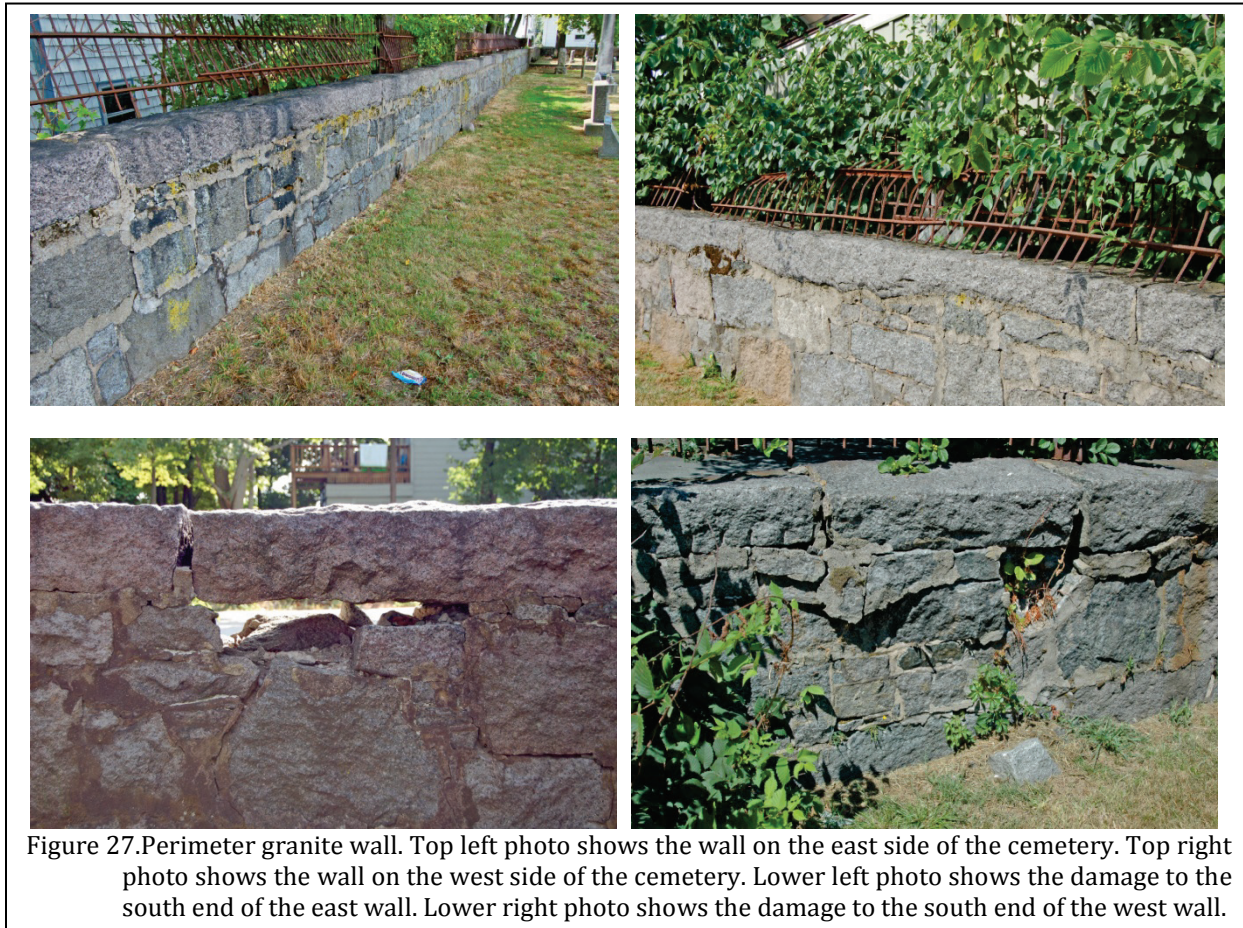
There are two damaged areas. One, noted in 1999, is situated at the south end of the east wall. The second area, apparently more recent, is on the south end of the west wall. At both

Figure 27. Perimeter granite wall. Top left photo shows the wall on the east side of the cemetery. Top right photo shows the wall on the west side of the cemetery. Lower left photo shows the damage to the south end of the east wall. Lower right photo shows the damage to the south end of the west wall.

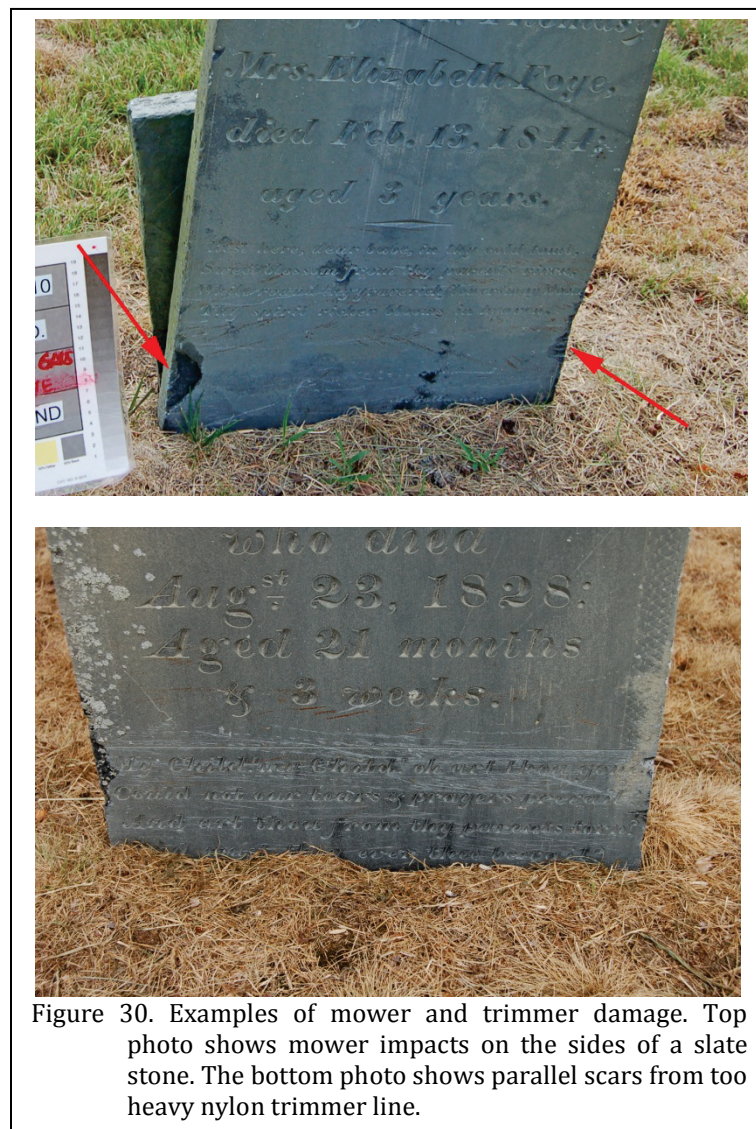
Figure 30. Examples of mower and trimmer damage. Top photo shows mower impacts on the sides of a slate stone. The bottom photo shows parallel scars from too heavy nylon trimmer line.

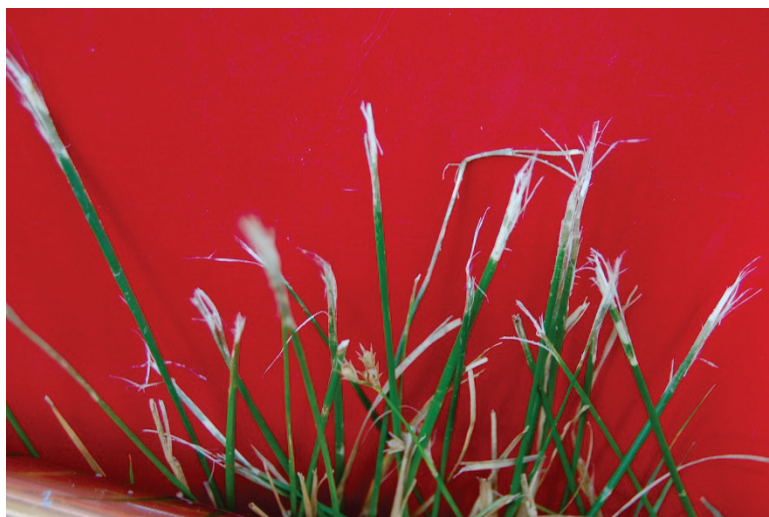
Figure 31. Grass at the Elm Street Cemetery has been cut with very dull mower blades, resulting in the leaves being torn, rather than cleanly cut.

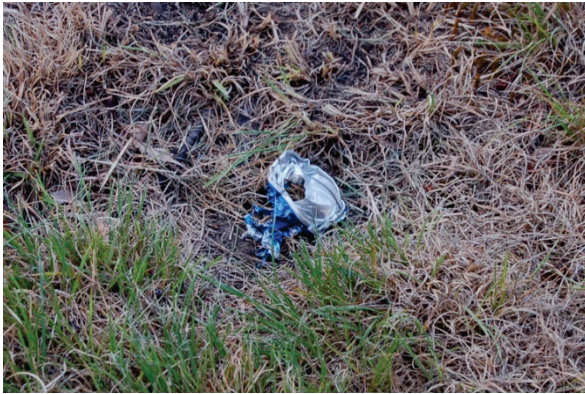
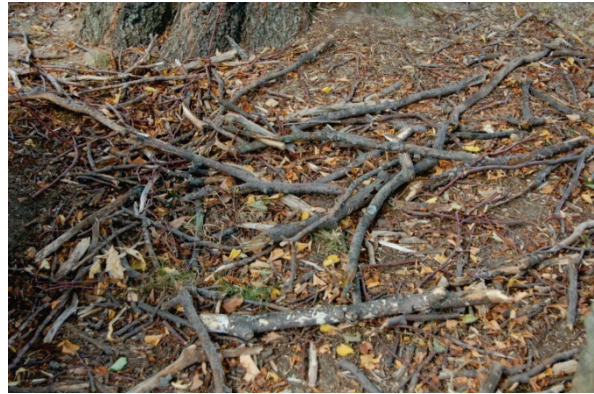
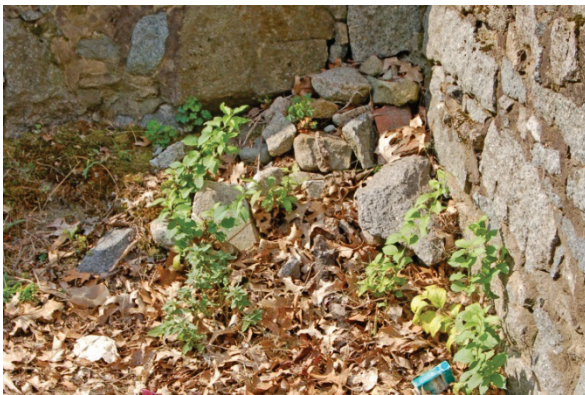
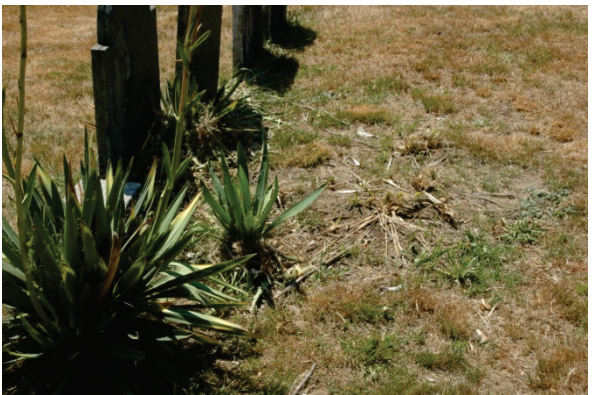
Figure 32. Unacceptable mowing practices include a failure to collect trash, litter, and branches prior to mowing and mowing over plantings.

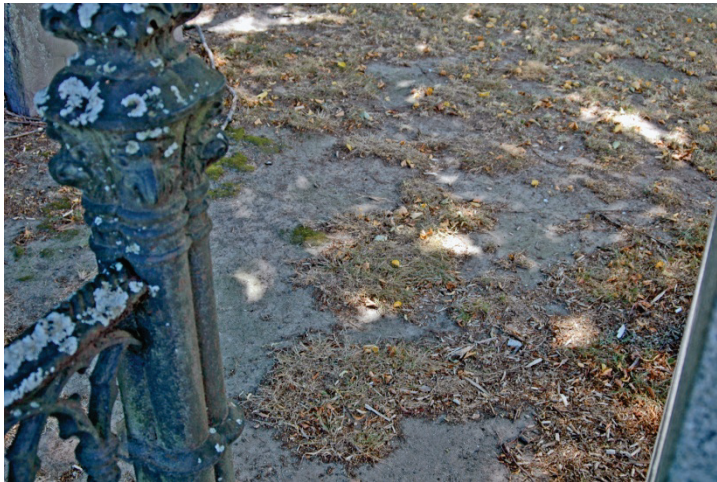
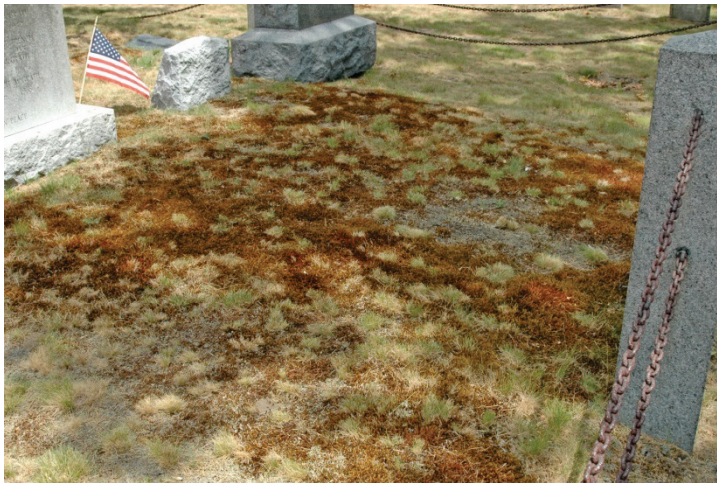
Figure 33. Lawn problems. The top photograph shows heavy soil compaction. The bottom photograph shows moss invading the turfgrass.

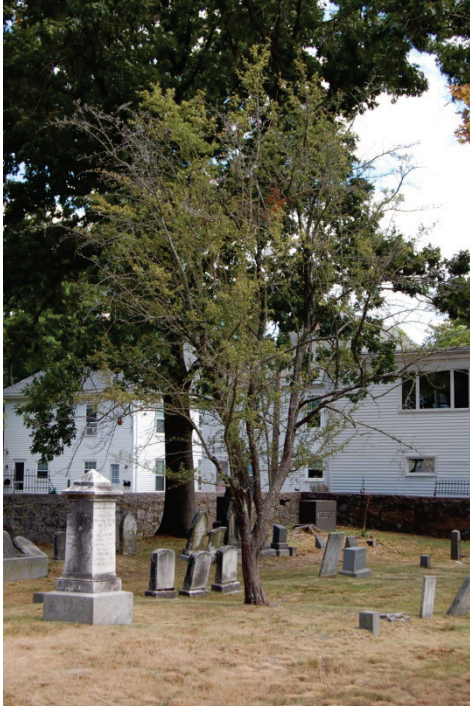
Figure 34. English hawthorn that requires pruning to remove dead wood.

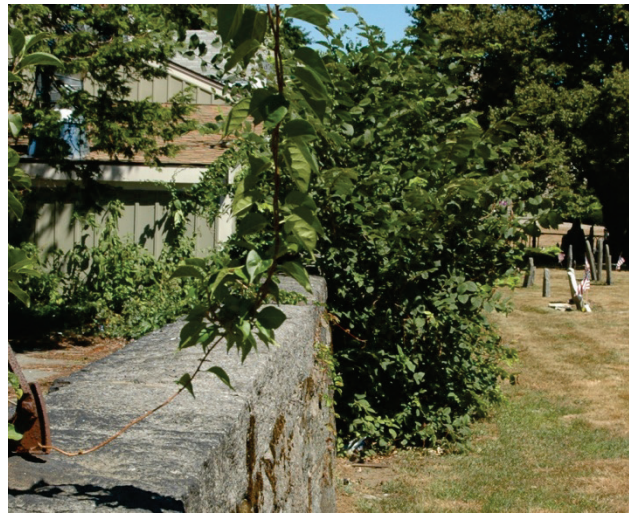
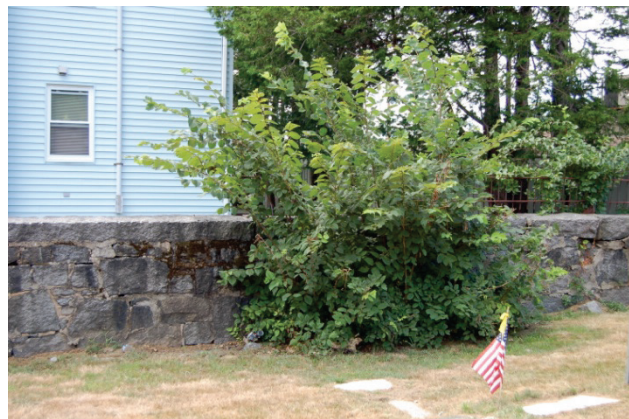
Figure 35. Voluntary trees that are detracting from the cemetery landscape and that may cause eventual damage to the cemetery wall. These trees and weedy plants should be removed.

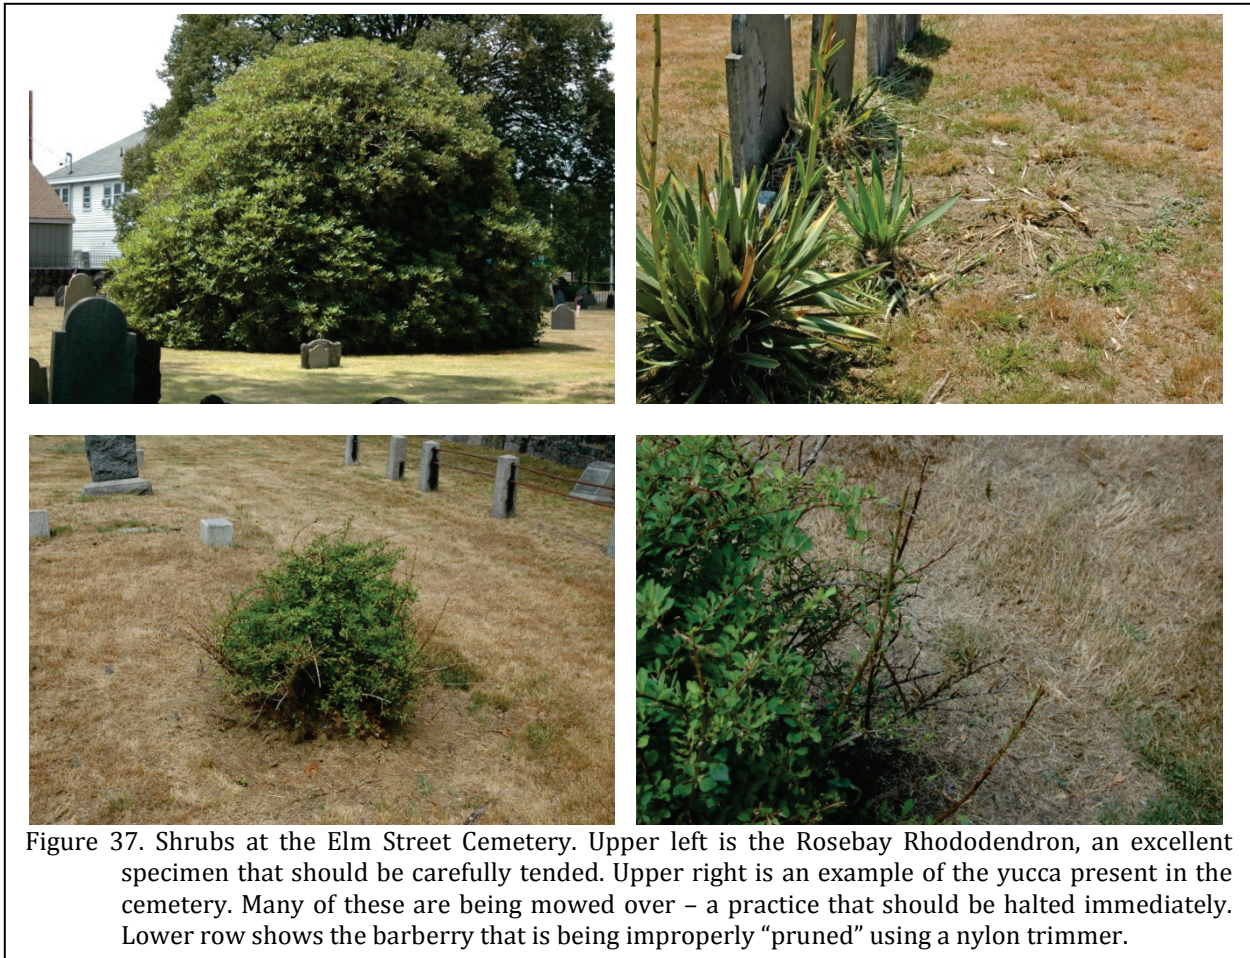
Figure 37. Shrubs at the Elm Street Cemetery. Upper left is the Rosebay Rhododendron, an excellent specimen that should be carefully tended. Upper right is an example of the yucca present in the cemetery. Many of these are being mowed over – a practice that should be halted immediately. Lower row shows the barberry that is being improperly “pruned” using a nylon trimmer.

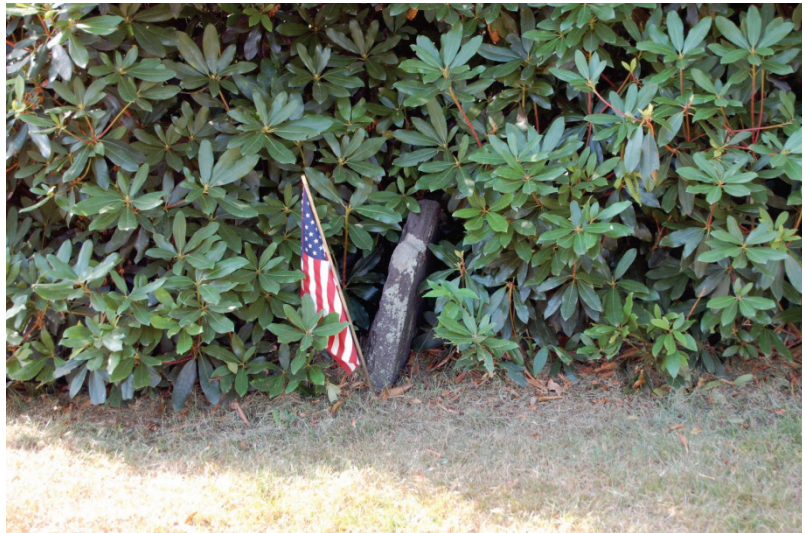
Figure 38. Stone at the edge of the rosebay rhododendron. Very judicious and careful pruning can help make the stone more visible without damaging this exceptional specimen.

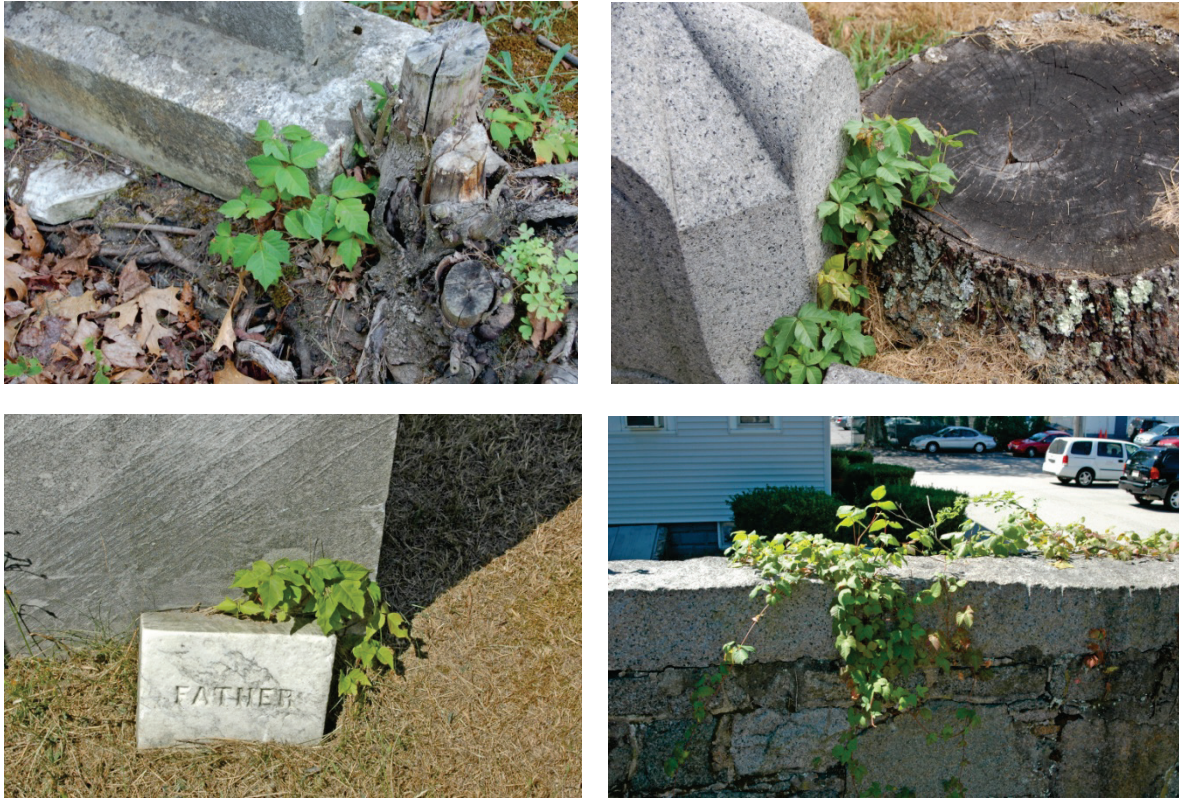
Figure 39. Poison ivy is beginning to become established in the cemetery and should be manually removed.

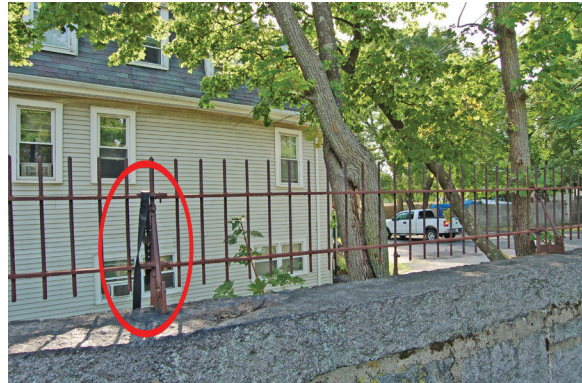
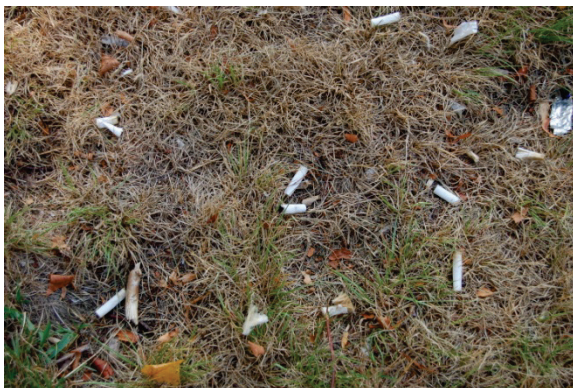
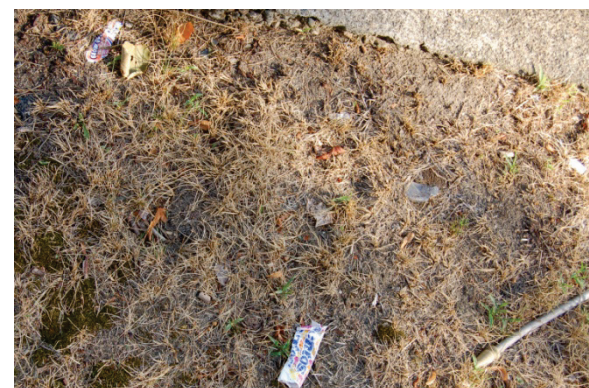
Figure 40. Trash at the Elm Street Cemetery.

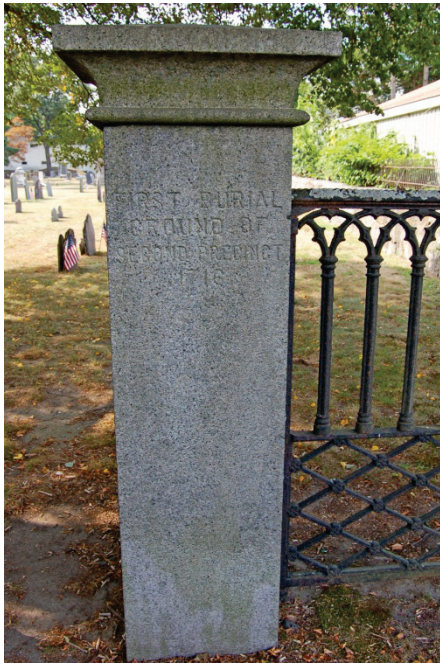
Figure 41. The only signage at the cemetery is understated, difficult to see from the street, and fails to promote visitation.

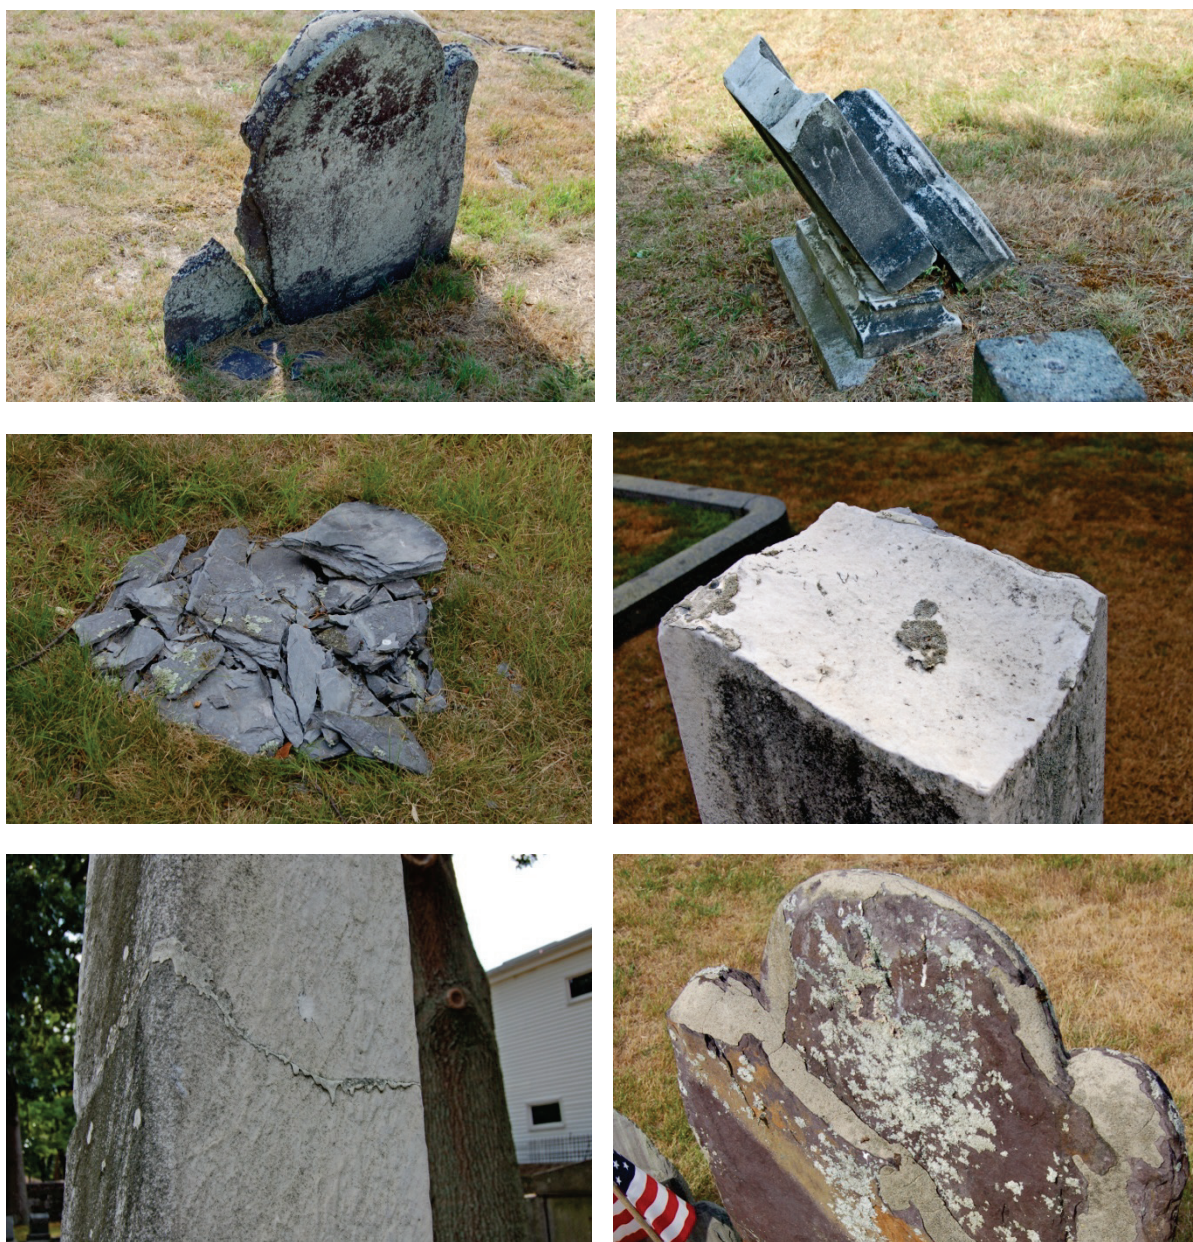
Figure 43. Examples of damaged stones requiring professional conservation treatments. Upper left shows a broken slate stone. Upper right is a broken marble stone that also exhibits setting using ferrous pins. Middle row left is a slate stone that fell and was never repaired. Today repair is impossible. Middle row right shows a failed “simple epoxy” repair. Bottom row left shows poor application of epoxy. Bottom row right shows a spalling slate stone that has been repaired using hard Portland cement. This repair is failing as the concrete is beginning to crack and allow water to intrude into the damaged slate, causing additional freeze-thaw damage.

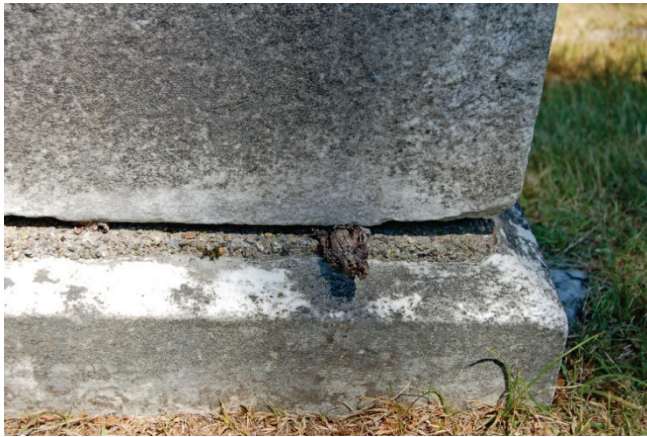
Figure 44. Example of a tilted stone that has been improperly “reset” using a branch to prop it up.

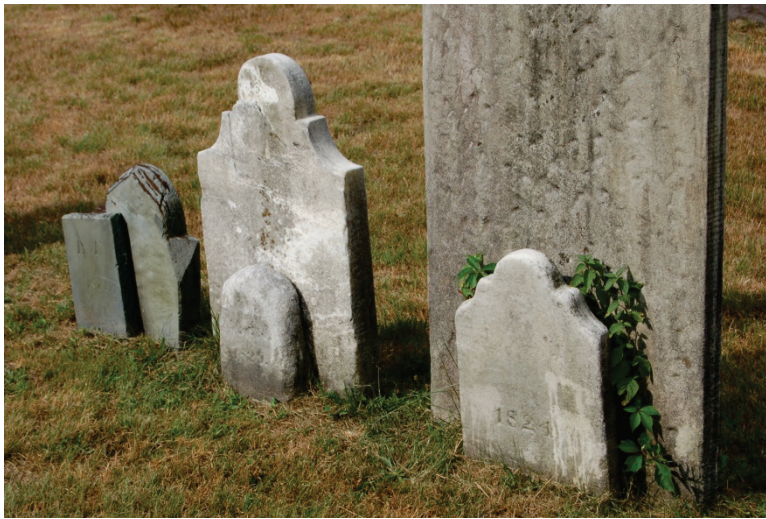
Figure 46. Footstones displaced for the convenience of mowing. These footstones should be reset about 5' behind their respective headstones.

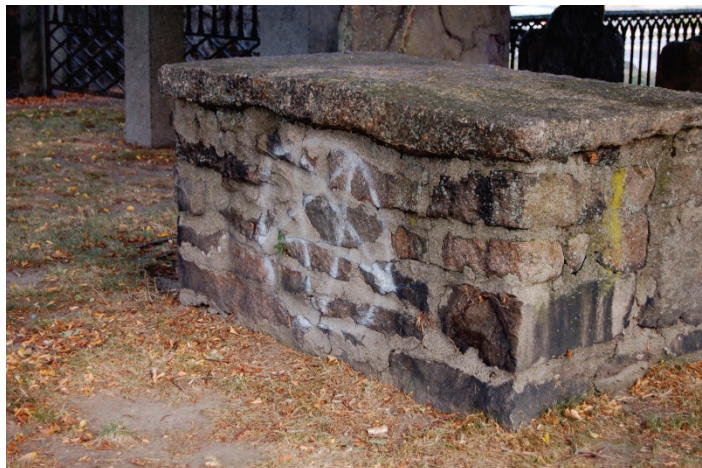
Figure 47. Graffiti on the Elizabeth Niles box tomb has been there for over a decade.
